### **Application to undertake work to tree subject to Tree Preservation Order**

T1 is located within the garden of Chomlea, 1A Longley Drive on the boundary line of the property and Worsley Road. The tree is subject to Tree Preservation Order 109 G19.

An application has been submitted (090218) to reduce the crown.

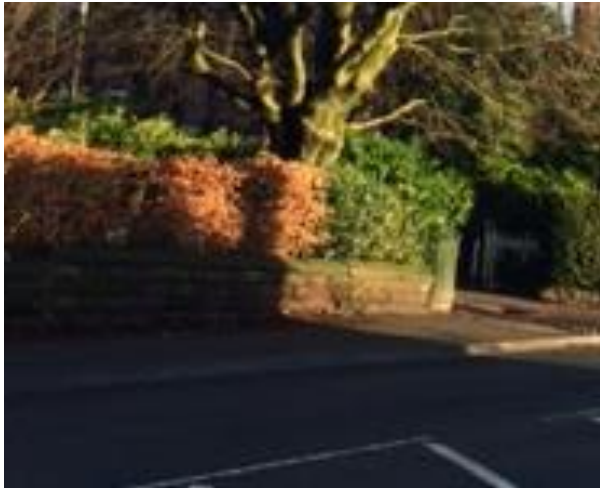
The tree is in a slightly raised bed and the perimeter wall had become in danger of collapse onto the pavement. Initially the expectation was the when the wall was dismantled it would reveal the cause of the problem with the wall would be expansion of the tree trunk, however when the wall and soil have been removed it has transpired that the root system of the tree has run parallel with the wall and is the cause of the wall collapsing.

**Image 1 - wall which was becoming dangerous due to risk of collapse onto pavement**

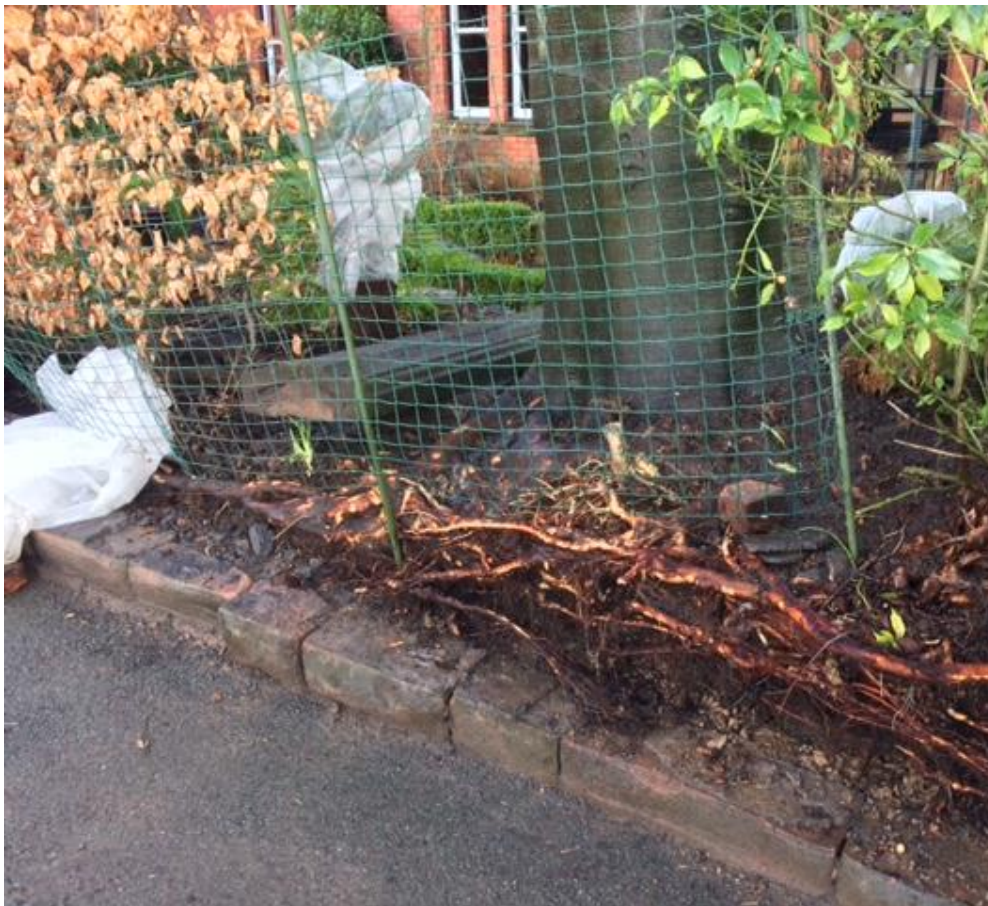
**Image 2 - Wall has been dismantled and revealed extent of stunted roots which are recommended to be removed**

It is recommended that the stunted roots which have caused the wall stones to be pushed out be removed by an arborist to ensure clean pruning thus reducing the potential for decay to enter into the wounds.

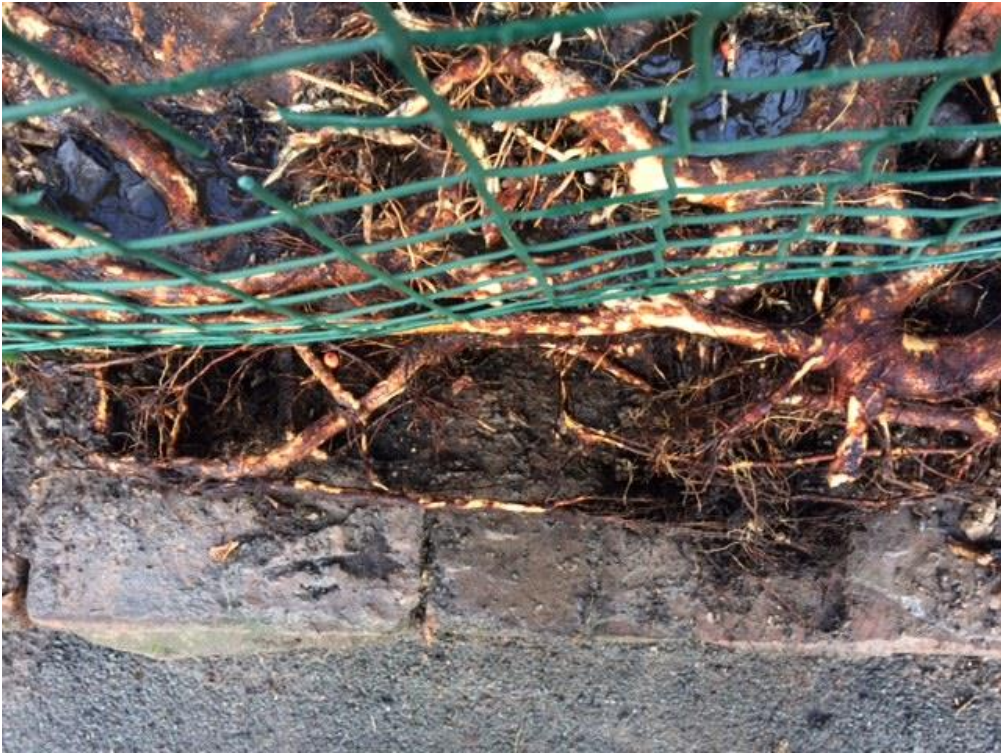
**Image 3 - Image taken above the roots**

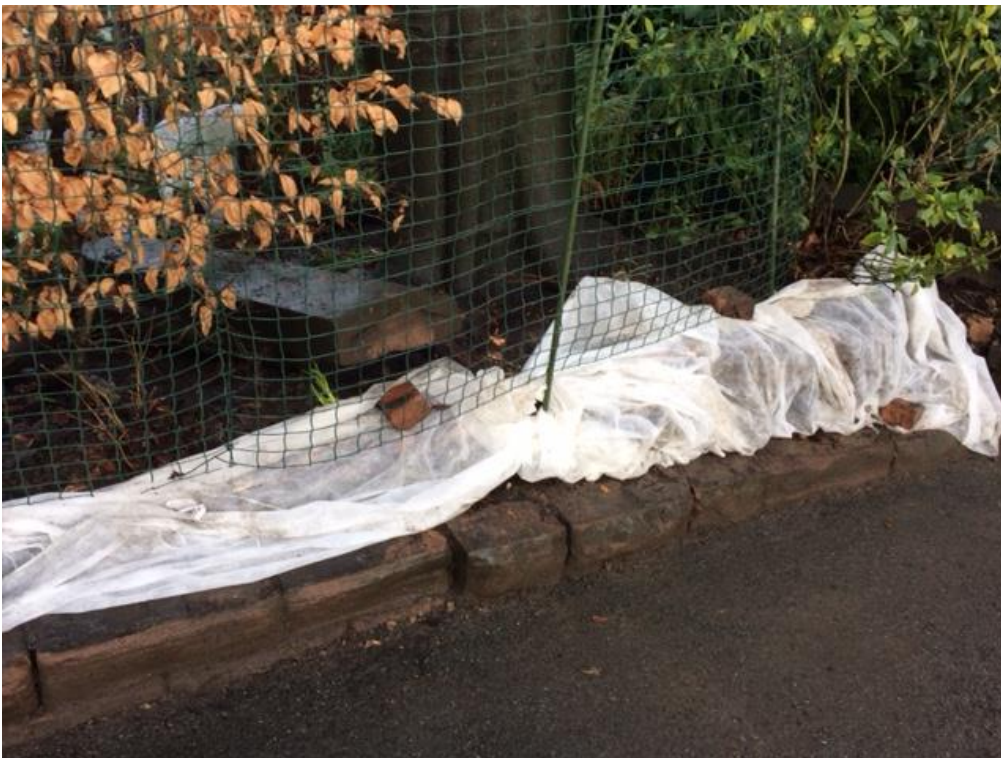
The owner of the property, Mr Smith, has taken all steps recommended by Birtle Tree Services to ensure the roots are protected during the investigation process. Mr Smith is very keen to retain the tree which is a very healthy mature specimen. The tree has a number of previous pruning sites which have callused over well and at the present time is budding vigorously.

**Image 4 – roots are being protected whilst approval from Local Authority is granted**
