## Phase I Geo Environmental Desk Study

No.8 The Pingot

Irlam

Report No. A2714/18

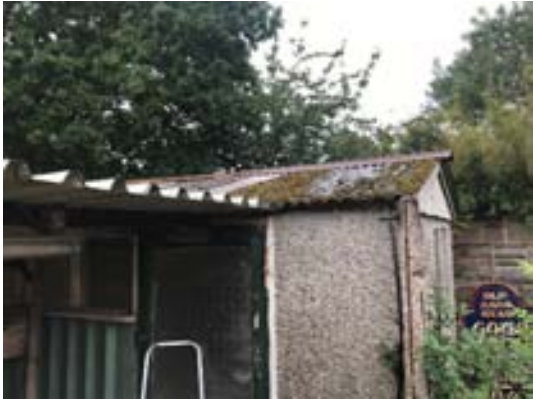
- 2.6 The southern part of the site is at an elevation approximately 0.5m lower than the garden of the residential property, and is occupied by a single storey, dilapidated shingle cladded out-house/shed structure with corrugated metal panel roof.

| <p><b>Plate 5 Northern elevation of shed structure in southern part of site, looking S</b></p> | <p><b>Plate 6 View of items stored/discarded in outbuilding/shed structure</b></p> |

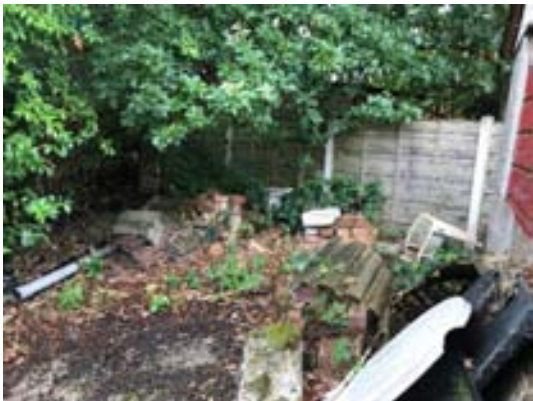
- 2.7 The area around the shed is used for discarded/disused and unwanted gardening items, building materials (bricks/tiles) and gardening waste (logs, branches etc).

| <p><b>Plate 7 Building materials stored in southern part of site, looking S</b></p> | <p><b>Plate 8 Western elevation of outbuilding/shed with suspected asbestos cement panelling, looking E</b></p> |
