# 14 Blackfield Lane, Salford Biodiversity Survey

May 2022

**Dunelm Ecology**  
consultant ecologists

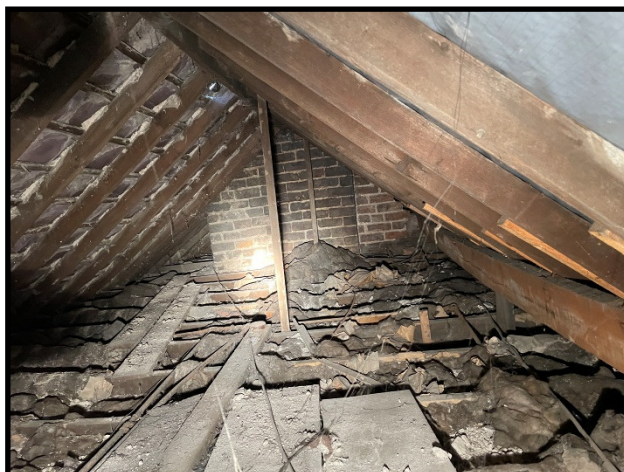
**Plate 1 Roof void**

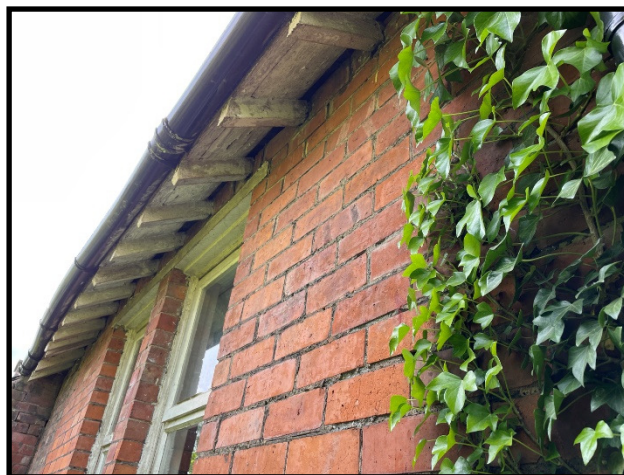
- 3.1.1 Table 2 below provides the results of the daytime inspection survey. In summary, no bats or signs of bats were recorded during the survey, although the building is assessed as having moderate potential to support roosting bats owing to the presence of several gaps around the eaves and under roof/ridge tiles while the dwelling is located immediately adjacent an extensive area of woodland which slopes down to the River Irwell 290 m to the south. Such habitats mean bat roosts are likely to be abundant in the area.

**Plate 3 Gaps under eaves on east elevation**

- 4.1.1 There is no evidence that the building is used by roosting bats although it is assessed as having moderate roost potential. Some bat species such as pipistrelle spp. are itinerant in their roosting habits and sometimes leave no clues of their presence, particularly when only low numbers of bats are present (Mitchell-Jones 2004) and bats utilise external roosting features. The possibility of a non-breeding roost occasionally used by solitary or low numbers of bats should therefore not be discounted. Further survey effort in the form of dusk emergence and/or return to roost surveys is therefore recommended to give confidence in the initial negative survey result and to comply with best practice guidelines (Collins 2016). Such surveys can only be undertaken between May and August during suitable weather conditions i.e. warm ( $>8^{\circ}\text{C}$ ), calm and dry, with at least two weeks between each survey.

- 4.1.2 Should further survey confirm the presence of bats and roost sites be directly impacted, then renovation works will need to be completed under licence from Natural England. Roost sites for bats should be incorporated into the scheme whether bats are present or not, in accordance with the NPPF which seeks net gains in biodiversity. This could be achieved by installing several integral bat roosting units within the external walls.

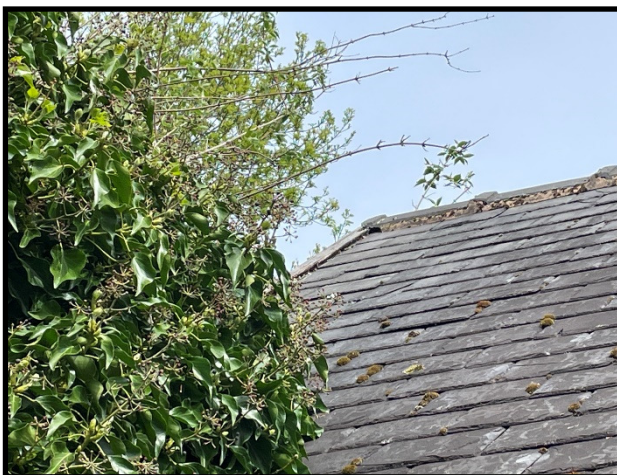
**Plate 4 Occasional gaps exist under roof slates and ridge tiles**
