**Archaeological Evaluation  
and Excavation**

**Derwent Street, Salford,  
Greater Manchester**

**Technical Report:**

SA/2022/109

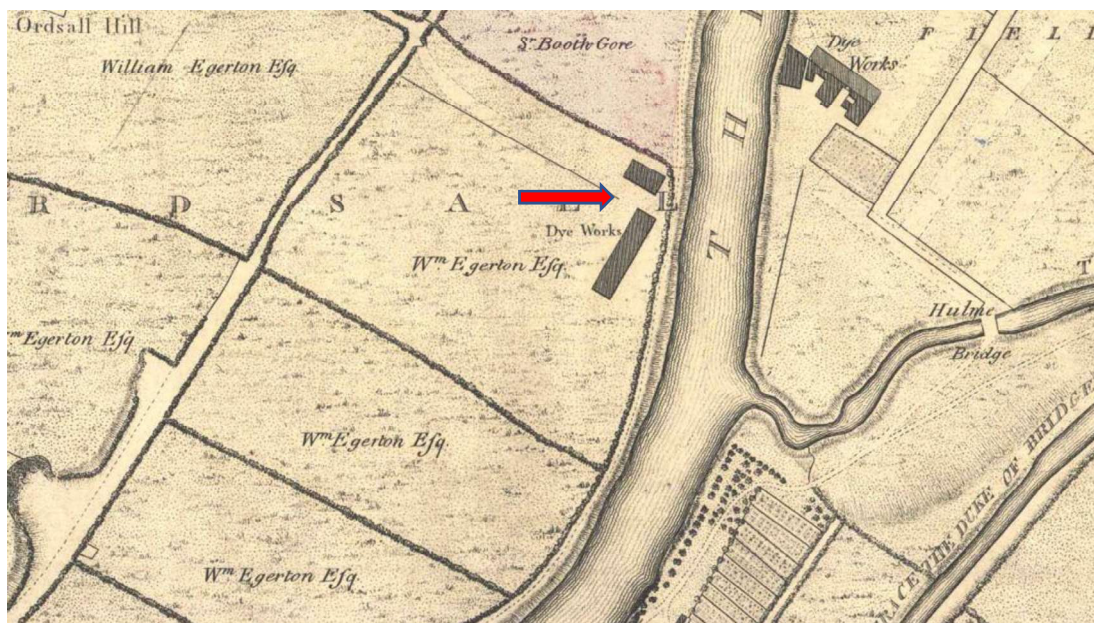
Plate 2: Green's 1794 map, with arrow pointing to site where the 'Dye Works' are shown near the River Irwell, north at top

- 4.6.1 Historical maps suggest that the site had begun to be developed for industrial purposes by the late 18<sup>th</sup> century. The earliest available map of the site (Laurent's map of 1793) shows an unlabelled building adjacent to the River Irwell surrounded by fields (Plate 1). Green's 1794 map shows that an additional building to the north of the original had been added within a year (Plate 2). This map also labels the buildings as 'dye works'.

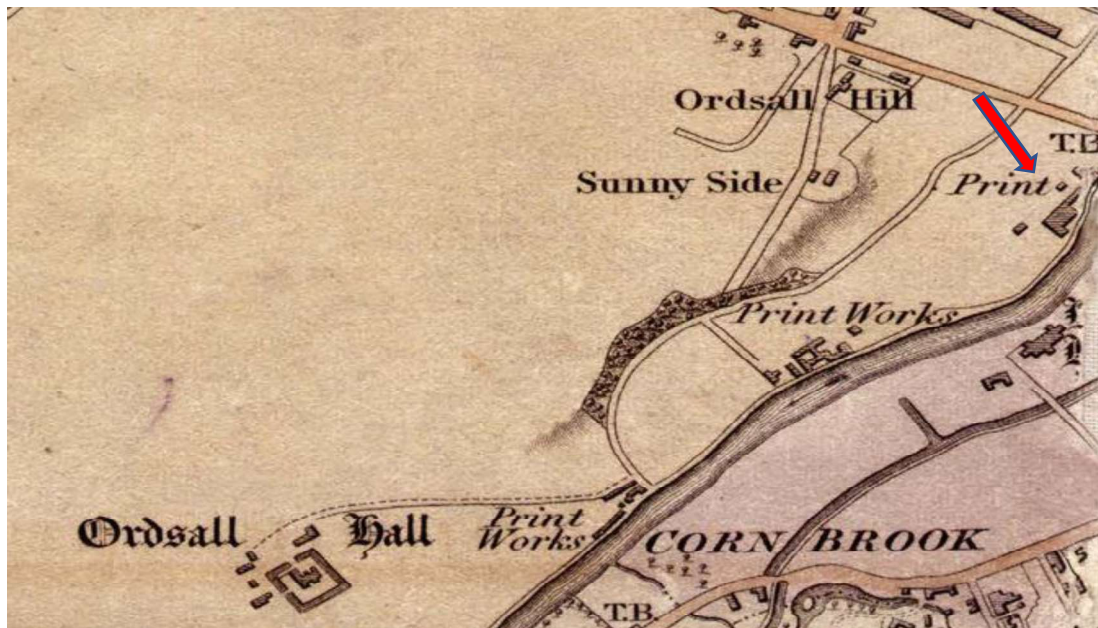
Plate 3: Johnson's 1820 map, with arrow pointing to the site, which is labelled 'Print', north at top

- 4.6.2 Johnson's map of 1820 (Plate 3) suggests that the two original buildings had been replaced by a larger structure, along with the addition of two satellite buildings. This map also annotates the building as 'Print', which presumably refers to its function as a print works. This appears to have been a mistake as Banks's map (Plate 4) indicates that the buildings were still used as 'dye works' in 1831 (Plate 4).

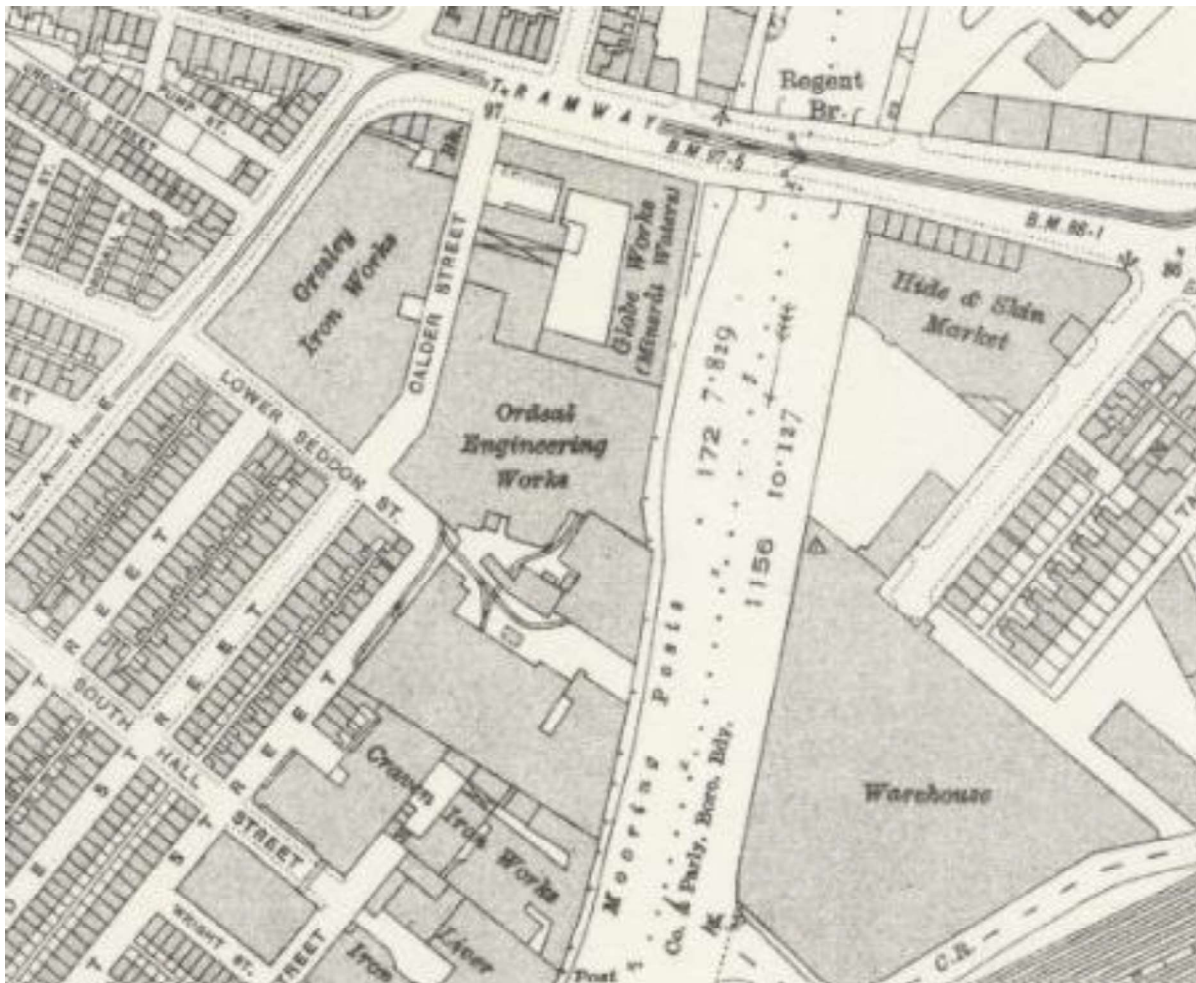
*Plate 7: Ordnance Survey of 1922, with arrow pointing to the site, north at top*

- 4.6.4 By 1922 the Sunnyside Mills had been renamed 'Ordsal Engineering Works' and the individual structures forming the Sunnyside Mill complex had been subsumed by larger sheds.
- 4.6.5 The Ordnance Survey map of 1980 (not included in report) suggests that the Ordsal Engineering Works complex was still intact by this date.

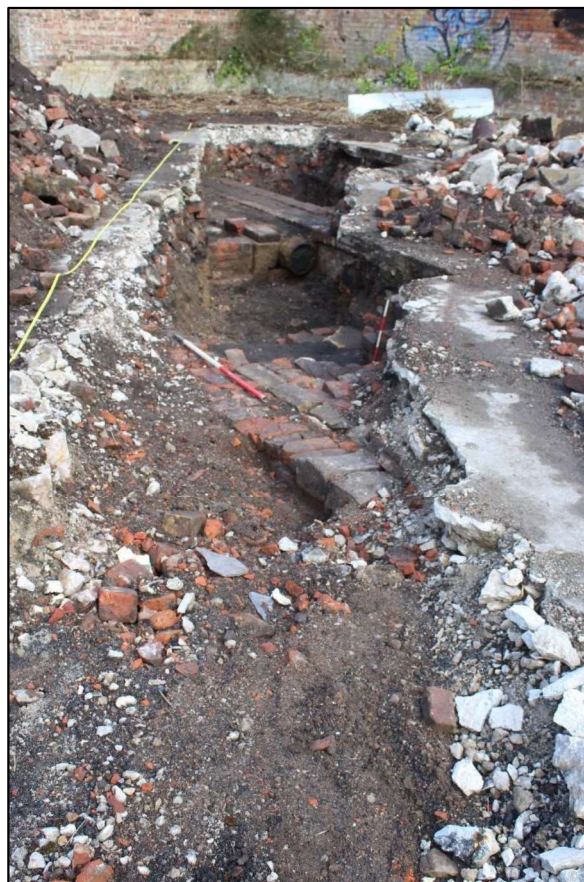
*Plate 6: General shot of Trench 1, looking north-west. Scales = 1 x 1m and 1 x 0.5m.*

- 6.2.1 Trench 1 (Plate 6) was located in the north-eastern corner of the site, oriented northwest to southeast, and measured 13.4m long x 2.7m wide x 1.22m deep.

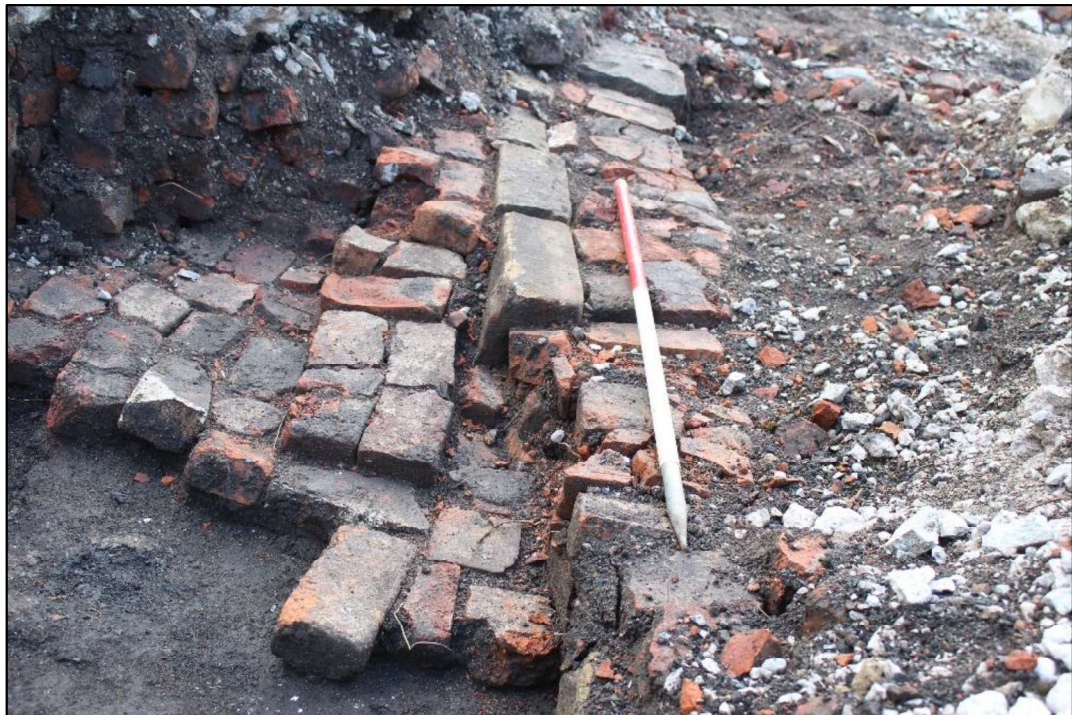
*Plate 7: General shot of coal dust deposit [114], brick surface [116], and brick wall [117], looking south-east. Scale = 1 x 1m.*

- 6.2.4 Deposit [114] was laid directly on top of deposit [115] and comprised a layer of coal dust located between walls [112] and [117]. Coal dust deposit [114] measured a maximum of 8.7m long x 2.7m wide x 0.08m thick. A red brick surface [116] was laid directly onto deposit [114], in the south-eastern corner of the trench, and abutted wall [117] on its north-eastern face. Brick surface [116] measured a maximum of 1.43m long x 1.05m wide x 0.24m deep. It was constructed of hand-made, unfroged red bricks and no visible bonding material survived.

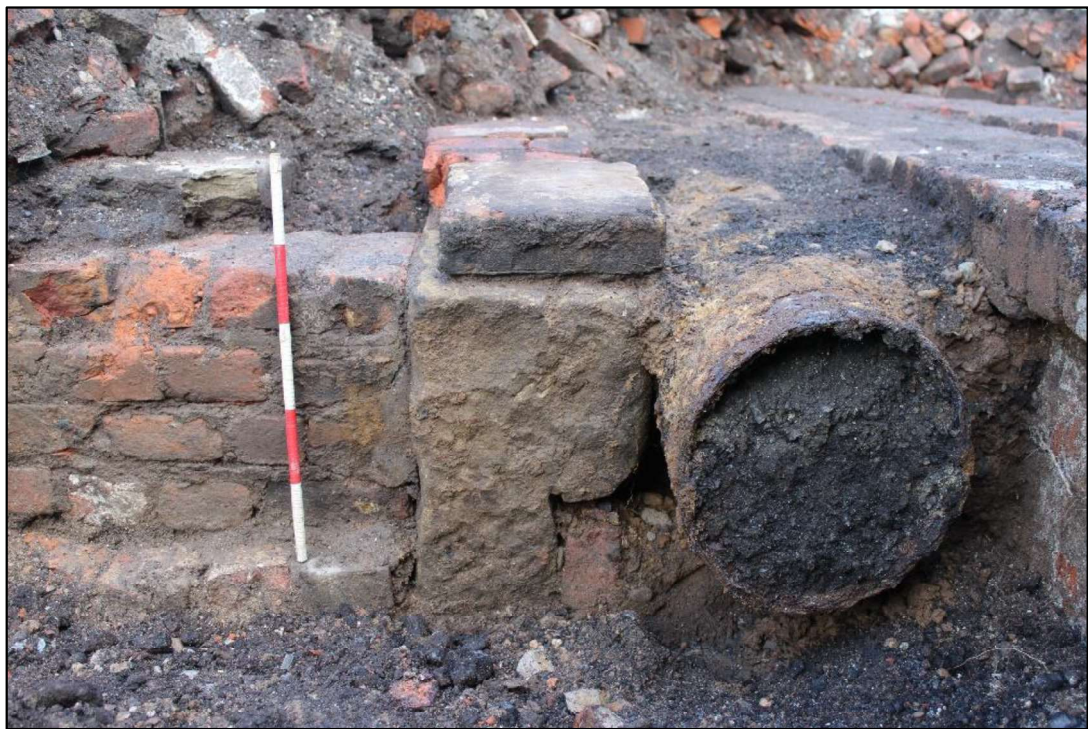
*Plate 8: General shot of sandstone block [108], brick wall [109], and cast-iron pipe [111], looking north-west. Scale = 1 x 0.5m.*

- 6.2.6 The sandstone block wall [108] measured a maximum of 1.24m long x 0.29m wide x 0.44m tall and had the remains of a red brick wall surviving on top at its south-eastern end (Plate 8). A small notch was cut out of the sandstone block wall [108] at the base of its north-eastern face.
- 6.2.7 A cast-iron pipe [111] was recorded in the centre of the trench and measured a maximum of 0.5m long and had a diameter of 0.3m (Plate 8). The pipe continued past the limit of excavation and so its actual length could not be ascertained. The pipe was filled with crushed coal. Brick wall [105] abutted wall [104] on its north-western end and measured a maximum of 3.2m long x 0.24m wide x 0.7m tall.

- 6.2.8 An L-shaped wall [109] was located in the north-western end of the trench, which measured a maximum of 0.55m long x 0.24m wide x 0.43m tall, although it did seem to continue past the limit of excavation (Plate 8). It was composed of hand-made, unfrogged red bricks and bonded with a sandy lime mortar. It was aligned north-west to south-east and ran parallel with wall [108], and it abutted the stone feature [108].
- 6.2.9

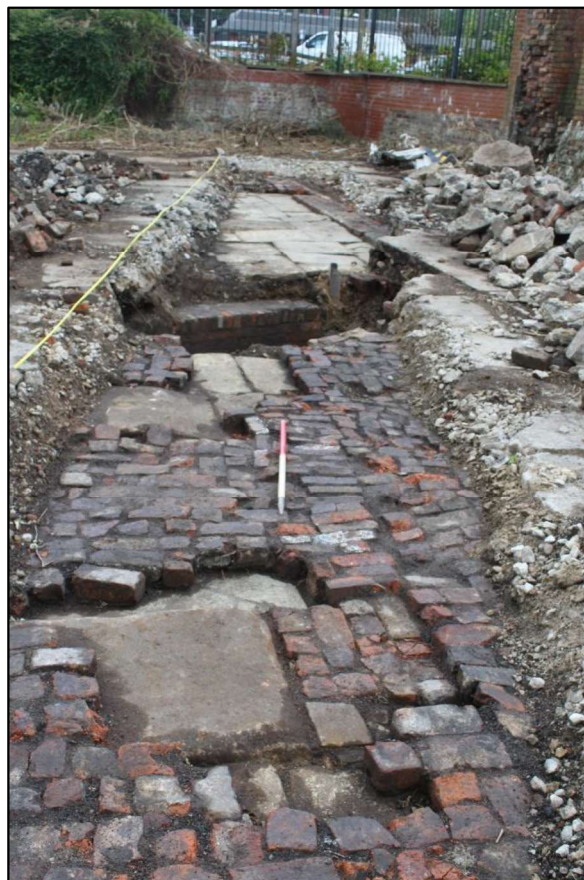
*Plate 9: General shot of Trench 2, looking north-west. Scale = 1 x 1m.*

- 6.3 **Trench 2 (Figure 3; Plate 9)**
- 6.3.1 Trench 2 was located south-west of Trench 1, aligned north-west to south-east, and measured a maximum of 17m long x 2.3m wide x 1.7m deep (Plate 9).

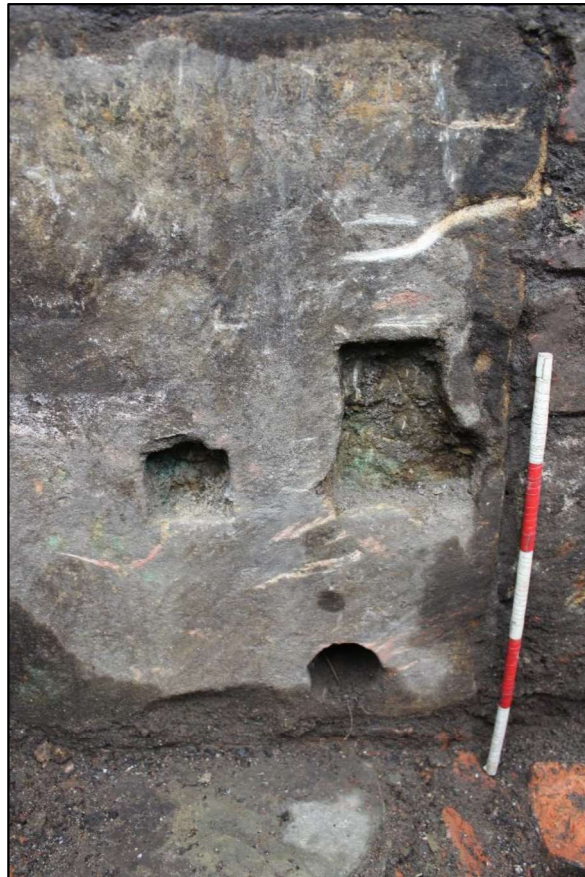
*Plate 10: General shot of stone block [212] and brick wall [205], looking south-east. Scale = 1 x 0.5m.*

- 6.3.2 The earliest remains observed in Trench 2 comprise a set of three stone blocks [212], [213] and [214] observed at the base of brick wall [205] in the centre of the trench and aligned north-east to south-west. Stone block [212] was the northernmost of the three and measured a maximum of 0.65m wide x 0.70m tall (Plate 10). It was situated at the base of wall [205] and had a circular hole at its base measuring 0.08m in diameter, and two sub-rectangular holes in its centre.

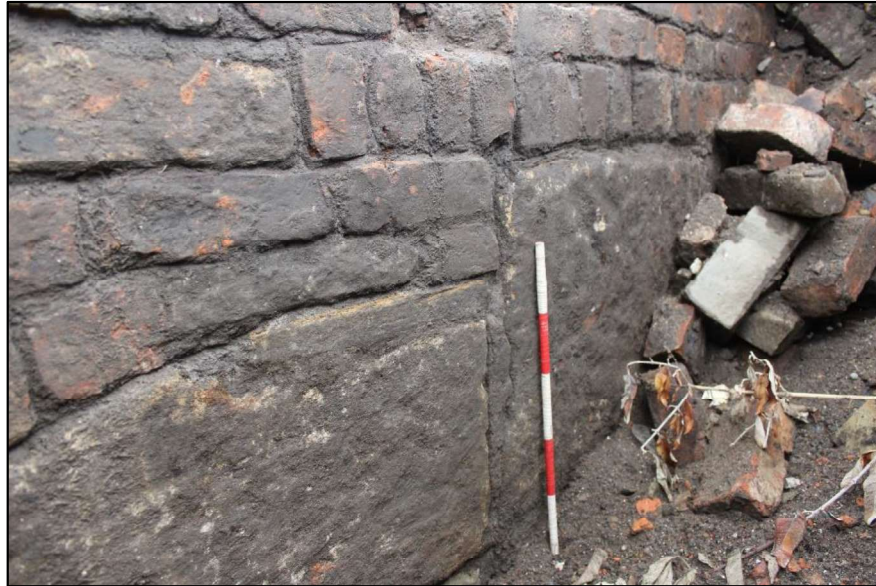
*Plate 11: General shot of stone blocks [213] and [214], and brick wall [205], looking south-east. Scale = 1 x 0.5m.*

- 6.3.3 Stone block [213] was the centre-most of the three blocks and measured a maximum of 0.71m wide x 0.4m tall (Plate 11). It was observed to have evidence of chisel marks on its face. Stone block [214] was the southern-most of the three blocks and measured a maximum of 0.66m wide x 0.61m tall (Plate 11). This block also had evidence of chisel marks on its face.
- 6.3.4 Wall [205] was located in the centre of the trench, aligned north-east to south-west, and measured 3.1m long x 0.36m wide x 1.1m tall. It was composed of handmade, unfrogged red brick laid a mix of header and stretcher bond. At the base of the wall

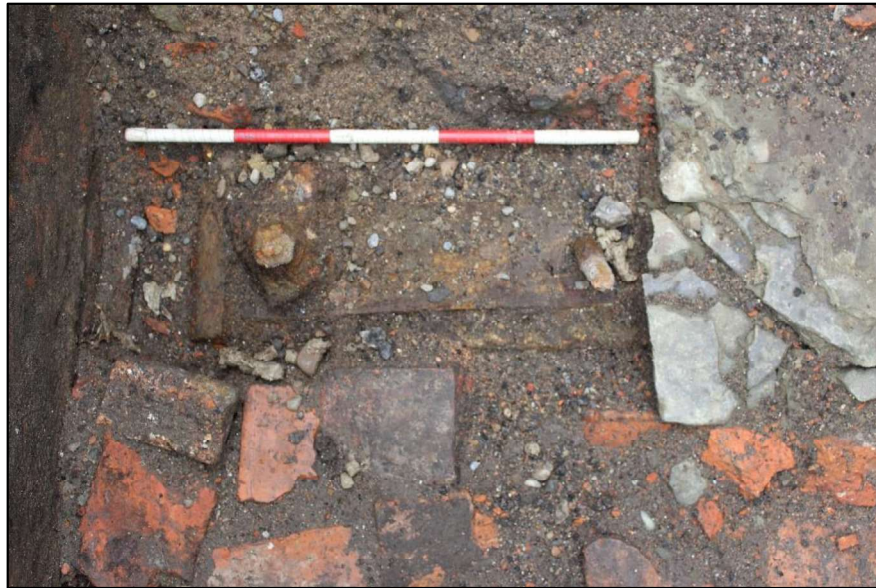
*Plate 12: General shot of iron and wooden mount set in surface [206], looking north. Scale = 1 x 0.5m.*

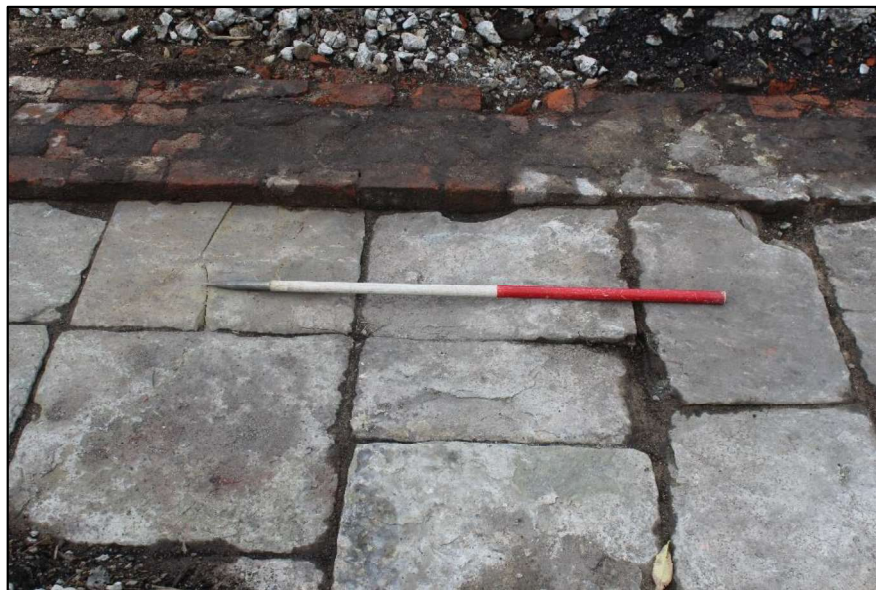
*Plate 13: Shot of Yorkstone flagged surface [203], looking north-east. Scale = 1 x 1m.*

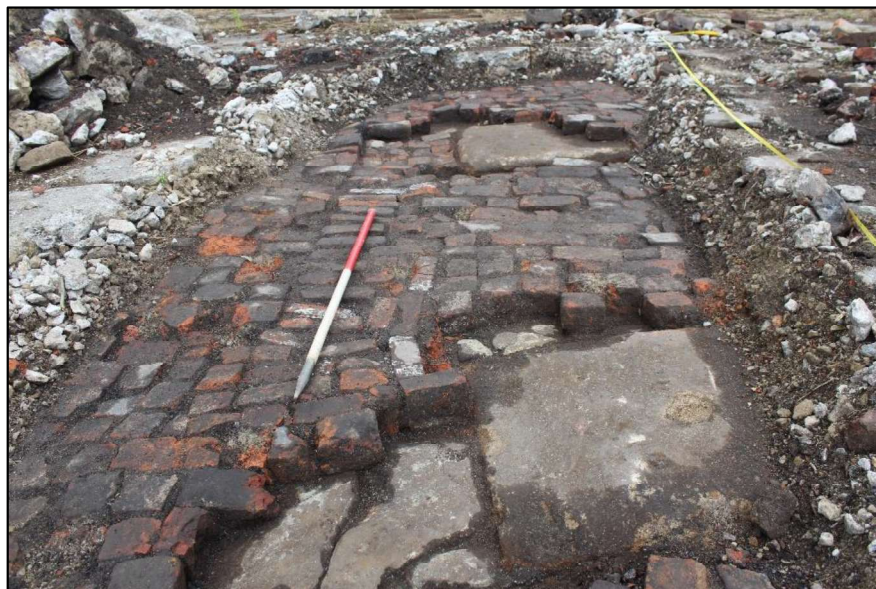
*Plate 14: Shot of Yorkstone flagged surface [209], Brick surface [207] and machine beds [208], looking south-east. Scale = 1 x 1m.*

- 6.3.10 Yorkstone flagged surface [209] was located south-east of wall [205] and measured a maximum of 5m long x 1.8m wide x 0.06m thick (Plate 14). It was laid directly onto bedding deposit [211] and had brick floor [207] and stone machine beds [208] around it.
- 6.3.11 Brick surface [207] was located south-east of wall [205] and measured a maximum of 5m long x 1.8m wide x 0.07m thick (Plate 14). The surface was constructed of roughly laid, handmade, unfrogged red bricks and had York Stone Flagged surface [209] and stone machine beds [208] within it. Stone machine beds [208] were set into brick floor surface [207] and measured a maximum of 0.77m long x 0.82m wide (Plate 14).

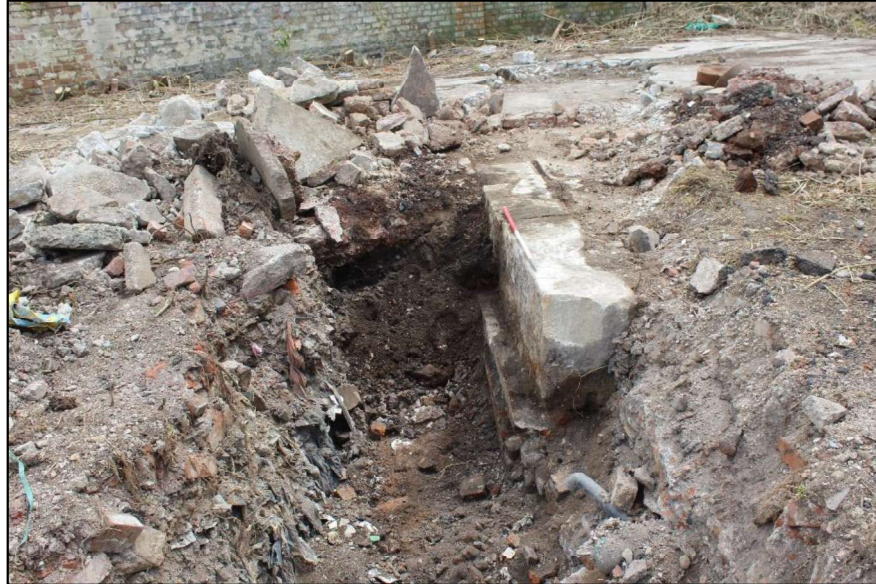
*Plate 15: General shot of sandstone blocks [302] and brick wall [303], looking south-east.  
Scale = 1 x 1m.*

- 6.4.1 Trench 3 was located south of Trench 2, aligned north-west to south-east, and measured a maximum of 19.3m long x 2.6m wide, and was deemed unsafe to enter due to the unstable condition of the trench edges (Plate 15).
- 6.4.2 The earliest remains observed in Trench 3 comprised three large sandstone blocks [302] laid end to end and located in the centre of the trench (Plate 15). The

westernmost block measured a maximum of 1.44m long x 0.44m wide x 0.53m tall. The centremost block measured a maximum of 1.47m long x 0.47m wide x 0.53m tall. The easternmost block measured a maximum of 1.4m long x 0.47m wide, its height could not be ascertained.

- 6.4.3 A single skinned brick wall [303] was observed surrounding the stone blocks of [302] (Plate 15). This was constructed of hand-made, unfrogged red brick laid stretcher bond and bonded with a sandy lime mortar.
- 6.4.4 A small section of north-east to south-west-aligned red brick wall was also observed north-west of stone blocks [302] and brick wall [303]. However, due to the unsafe nature of the trench this wall could not be properly recorded.
- 6.4.5 The entire trench was then sealed by a 0.26m thick deposit of modern concrete [301] making the modern floor surface.

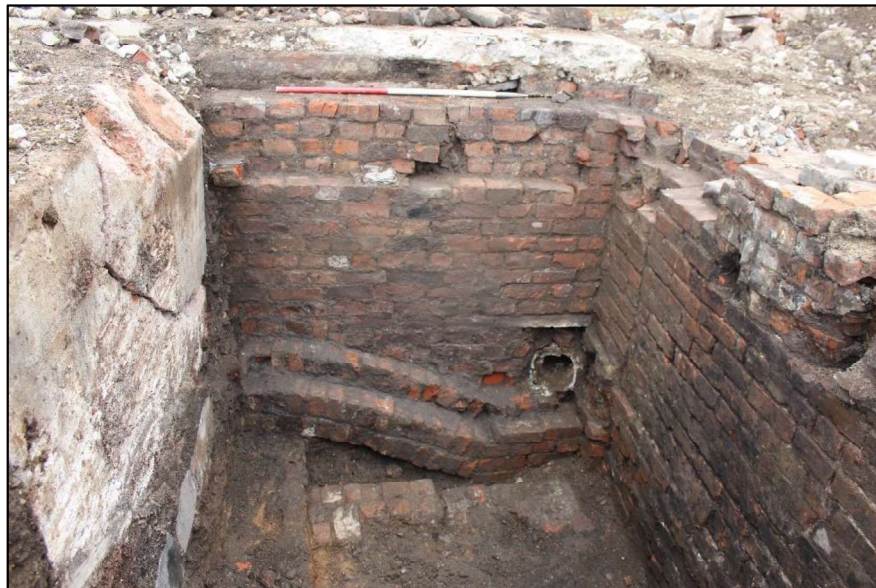
*Plate 16: General shot of L-shaped wall [503] with arch, cast-iron pipe [510], and wall [509] looking south-east. Scale = 1 x 1m.*

- 6.6.6 Wall [509] was located in the south-eastern end of the trench, was aligned north-north-east to south-south-west, and measured a maximum of 1.4m long x 0.36m wide (see Plate 16). A cast-iron pipe set in concrete [510] was observed to run under the arch in wall [503] aligned north-east to south-west, and over wall [509] (see Plate 16). The pipe measured a maximum of 0.90m long x 0.10m wide.

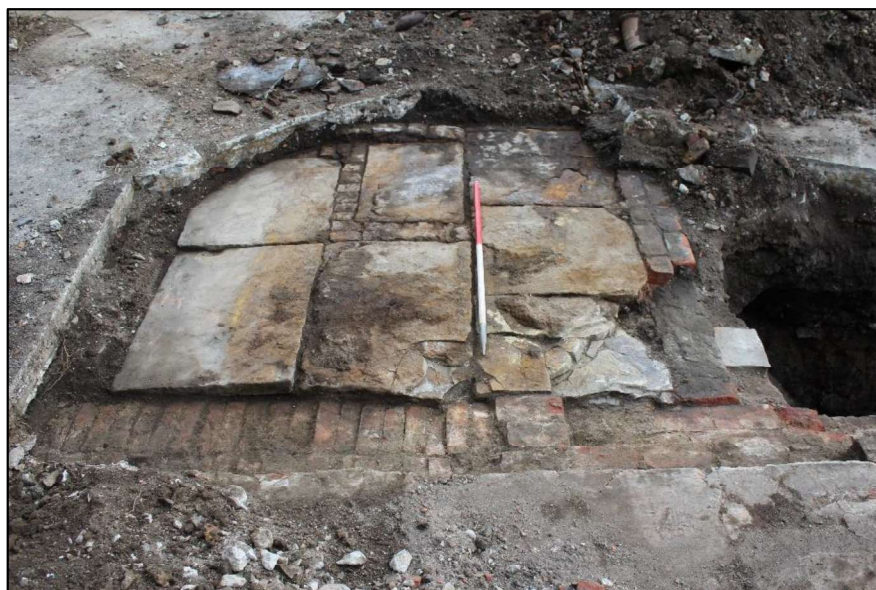
*Plate 17: Shot of Yorkstone flagged surface [502], looking north-east. Scale = 1 x 1m.*

- 6.6.5 Yorkstone flagged surface [502] was located in the north-western end of the trench in the room created by walls [503] and [506] and measured a maximum of 2.07m long x 1.84m wide x 0.05m thick (Plate 17). An L-shaped brick wall [504] was set into surface [502] aligned north-east to south-west and measuring 0.62m long x 0.16m wide, before returning on a north-west to south-east alignment, and measured a maximum of 0.90m long x 0.1m wide. A single row of cobble sets [505] was observed along the northern edge of Yorkstone flagged surface [502]. Cobble sets [505] were aligned north-west to south-east and measured a maximum of 0.73m long x 0.19m wide.

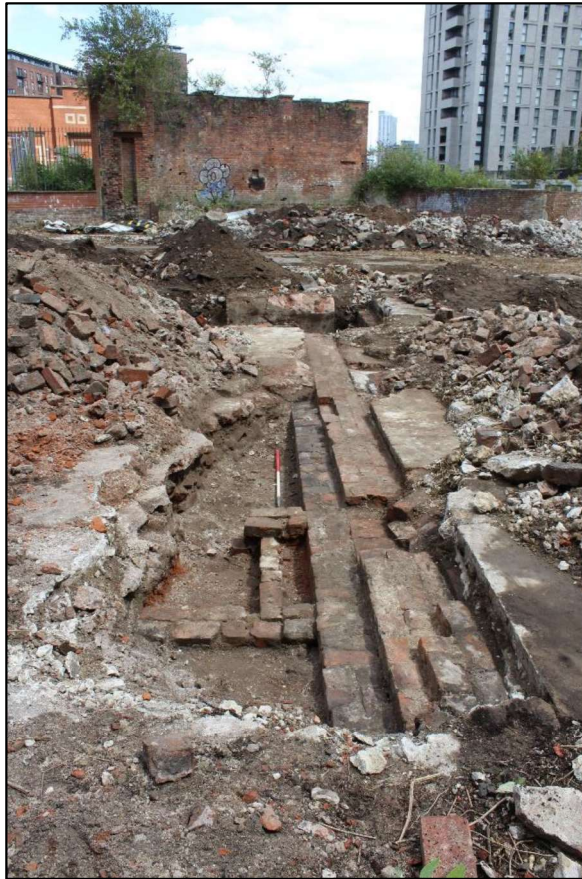
*Plate 18: General shot of Trench 6, looking north-east. Scale = 1 x 1m.*

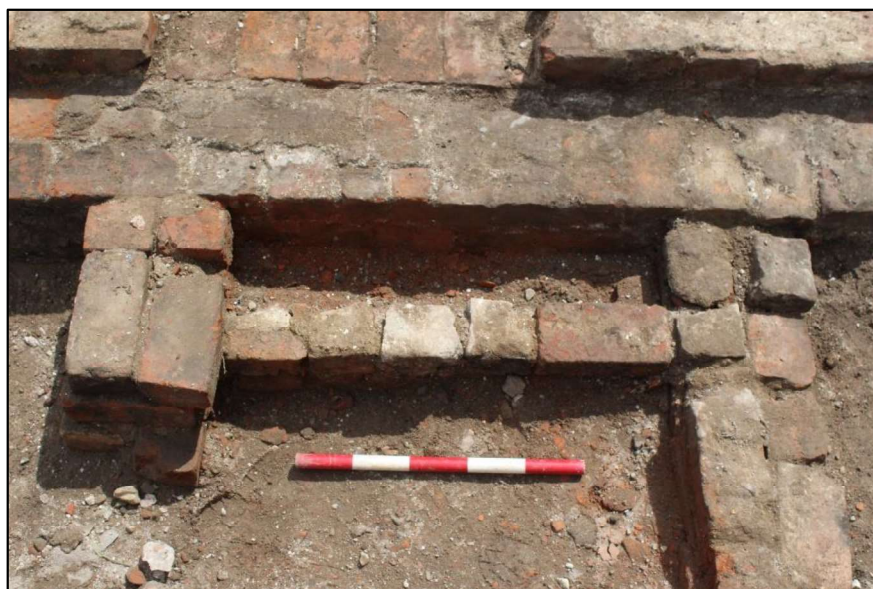
*Plate 19: Shot of H-shaped wall [6003], looking south-east. Scale = 1 x 0.5m.*

6.7.4 H-shaped wall [6003] was located in the south-western end of the trench abutting wall [6001] on its north-western face, was aligned north-east to south-west, and measured a maximum of 0.82m long x 0.23m wide x 0.14m thick (Plate 19). Wall [6003] was

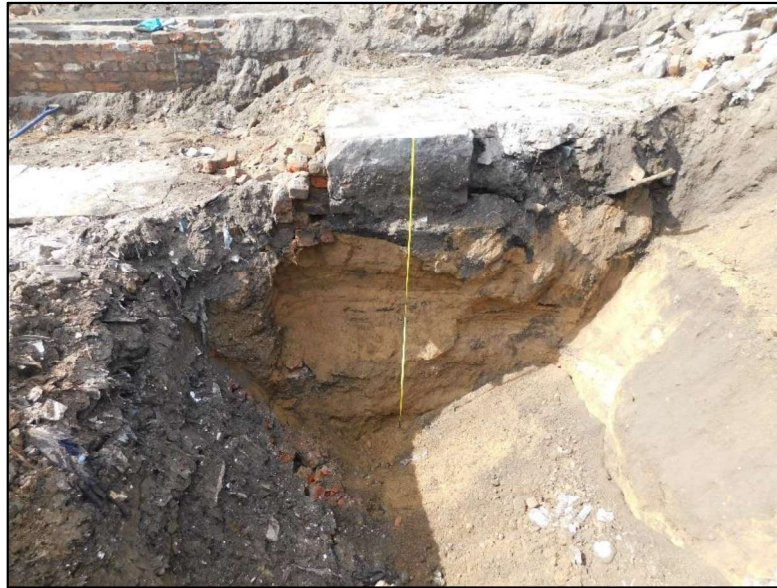
*Plate 20: Shot of sandstone stanchion [103] and wall [104], looking south-west.*

- 6.10.1 All of the structural archaeological remains observed in the excavation dated to the 19<sup>th</sup>-century Sunnyside Mill.
- 6.10.2 Sandstone block [103] was located in the south-western half of the northern end of the area, was aligned north-east to south-west, and measured a maximum of 0.8m long x 0.75m wide x 0.90m thick (Plates 20 and 21). The block was composed of roughly hewn sandstone, was laid directly on the geological natural substrate [105], and abutted wall [104] on its north-western face. It was thought that block [103] may have been disturbed by a later landfill on site.

- 6.10.3 Wall [104] was located south-east of sandstone stanchion [103] and abutted it on its south-eastern face. The wall was aligned north-east to south-west and measured a maximum of 2.1m long x 0.36m wide x 0.42m tall. Wall [104] was constructed of hand-made, unfrogged red brick, and bonded with a sandy lime mortar. Wall [104] abutted wall [119] on its north-eastern face, and floor surface [117] on its north-eastern edge.

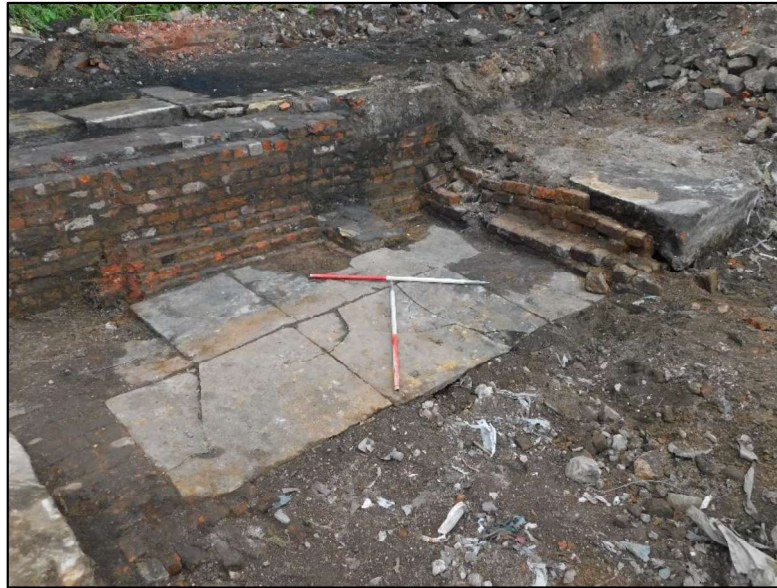
*Plate 21: Shot of stanchion [115], wall [119], surface [117], wall [104] and stanchion [103], looking south-west. Scales = 2 x 1m.*

- 6.10.7 Surface [117] was located in the north-western corner of site abutting wall [104] and stanchion [115]. Surface [117] measured a maximum of 3.49m long x 1.83m wide x 0.42m thick (Plate 21). It was constructed of hand-made, unfrogged red brick and York Stone flagstones, and bonded with a sandy lime mortar. The highest level of the surface measured 24.88m aOD.

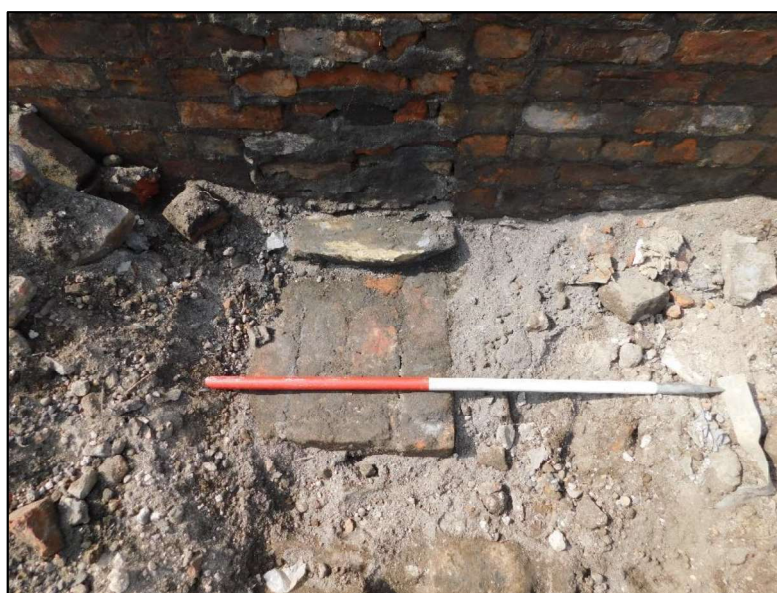
*Plate 22: Shot of stanchion [113] and wall [107], looking south-west. Scale = 1 x 1m.*

- 6.10.9 Stanchion base [113] abutted wall [107] on its north-eastern face near its centre and measured a maximum of 0.6m long x 0.47m wide (Plate 22). It was composed of hand-made, unfrogged red brick and bonded with a sandy lime mortar. A stone plinth originally sat on top of the brickwork but was unfortunately damaged and most was removed during excavation. A small section of the stone survived, however. At its highest level it measured 24.90m aOD.
- 6.10.10 Machine bed [116] was located south-east of surface [117], was aligned north-west to south-east, and measured a maximum of 1.56m long x 1.09m wide x 0.19m thick. It was constructed of a single, roughly hewn, rectangular sandstone stone (Plate 23). Machine bed [116] had a rectangular recess carved on its top face along and four iron fixings. Its highest level measured 25.05m aOD and at its lowest level measured 24.89m aOD.

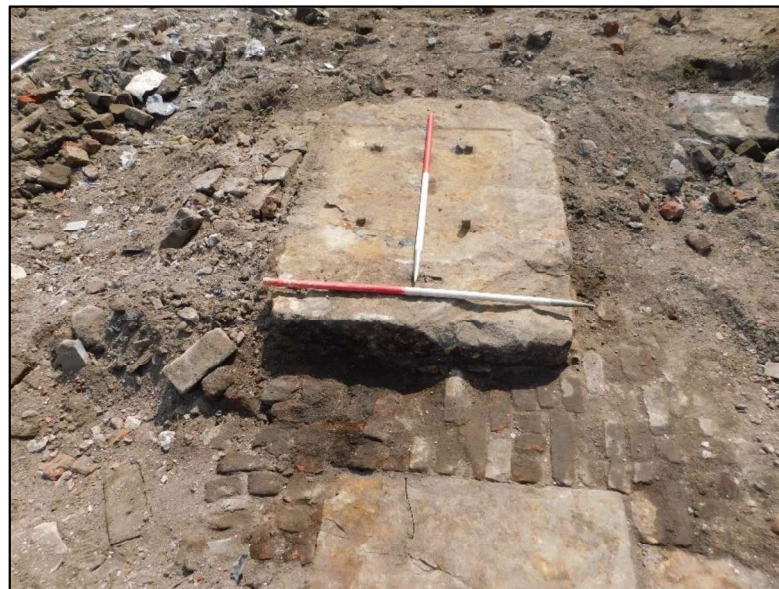
*Plate 23: Shot of machine bed [116] and surface [126], looking north-west.*

*Scales = 2 x 1m.*

- 6.10.11 Brick floor surface [126] was observed south-east of surface [117] and around machine bed [116] and measured a maximum of 2.72m long x 1.79m wide. It was composed of red handmade, unfrogged, red laid stretcher bond, and bonded with a dark greyish black mortar. This surface was badly truncated. Its highest level measured 24.90m aOD and at its lowest measured 24.76m aOD.
- 6.10.12 Stone block [127] was located south-east of brick surface [126] and machine bed [116], was aligned north-west to south-east, and measured a maximum of 1.08m long x 0.78m wide (Plate 24). It was composed of a single, rectangular, roughly hewn

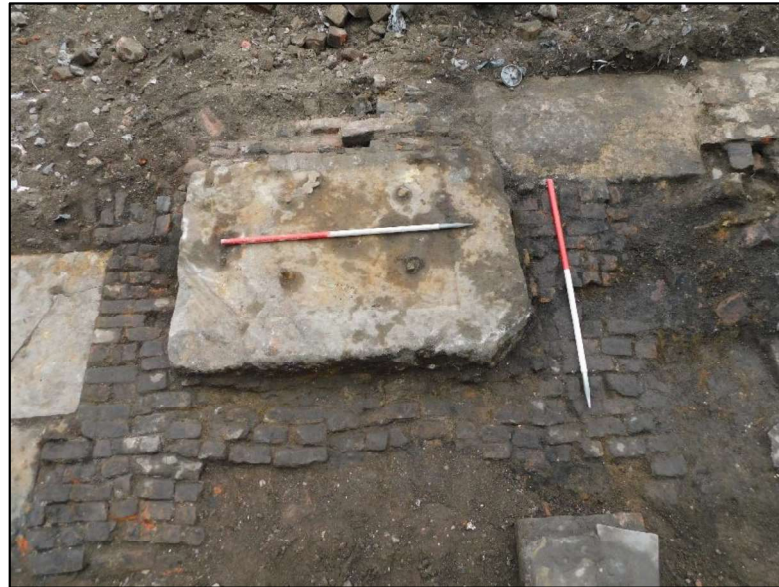
*Plate 24: Shot of machine bed [116], brick surface [126], and sandstone block [127], looking north-east. Scales = 2 x 1m.*

sandstone block. The block was slightly higher than brick surface [126], with its highest level measuring 24.93m aOD.

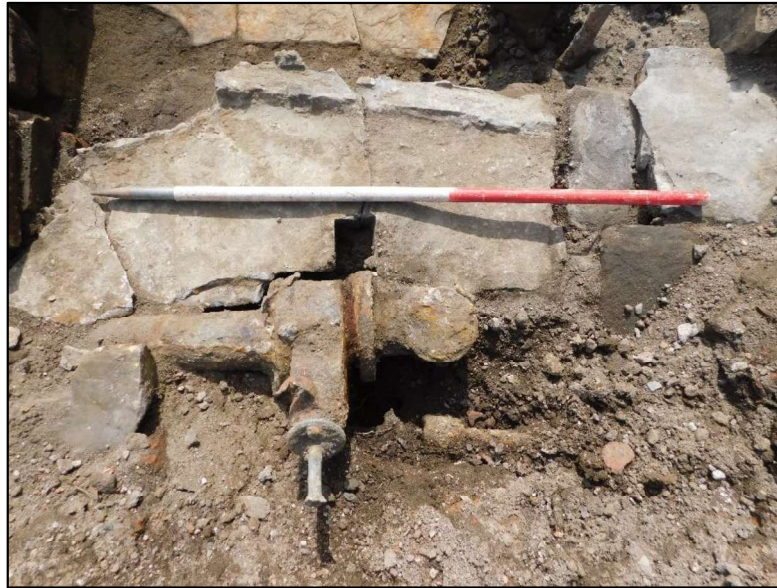
*Plate 25: Shot of cast-iron pipe [112] in concrete surround, looking south-east.*

*Scale = 1 x 1m.*

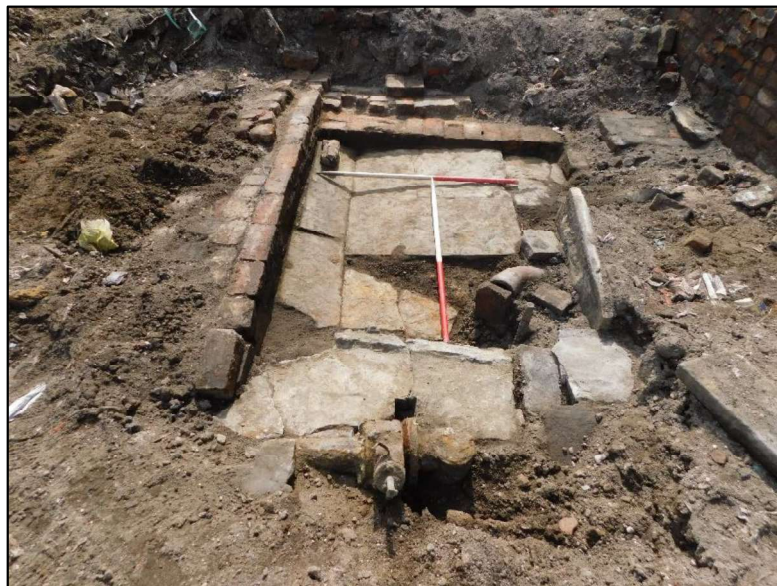
*Plate 26: Shot of cast-iron pipe [112], flagged surface [111], and walls [110], [108], and [109], looking south-east. Scales = 2 x 1m.*

- 6.10.15 Flagged floor surface [111] was located north-west of wall [108] and south-west of wall [110] and measured a maximum of 1.5m long x 1.5m wide (Plate 26). It was composed of Yorkstone flags and was truncated in the north-west corner by a blocked off ceramic pipe. At its highest level, surface [111] measured 24.70m aOD.

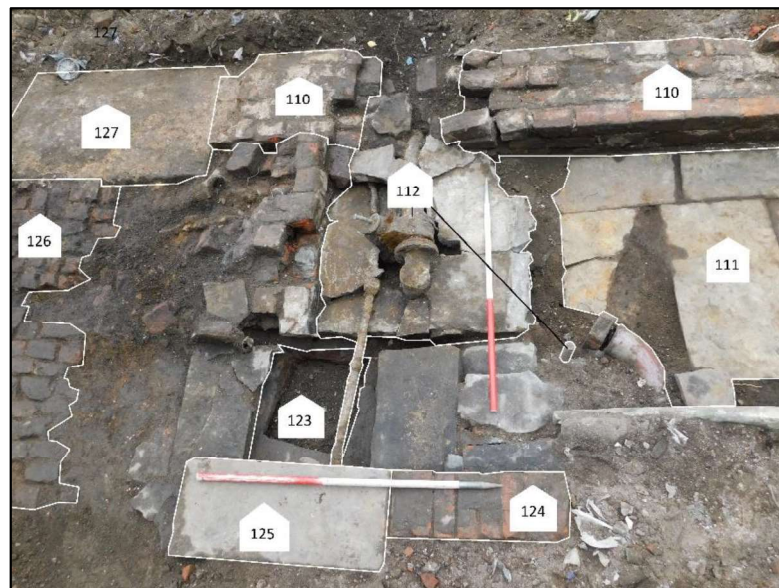
*Plate 26: Shot of sandstone block [127], brick surface [126], cast-iron pipe [112] with concrete and stone surround, flagged surface [111], walls [110], and [124], , doorstep [125], , and manhole [123], looking north-east. Scales = 2 x 1m.*

- 6.10.18 Possible timber-lined manhole [123] was located south-west of pipe [112] and measured a maximum of 0.9m long (Plate 27). Doorstep [125] was located just south-west of possible manhole [123], was aligned north-west to south-east, and measured a maximum of 0.81m long x 0.36m wide x 0.14m thick (Plate 27). It was composed of a single, roughly hewn sandstone block. The highest level of doorstep [125] measured 24.86m aOD. Brick wall [124] was located south-east of and abutted doorstep [125], was aligned north-west to south-east, and measured a maximum of 0.63m long x 0.23m wide x 0.12m tall (Plate 27). It was composed of hand-made, unfrogged red brick laid header bond, and bonded with a blackish brown mortar. Wall [124] measured 24.97 aOD at its highest point.

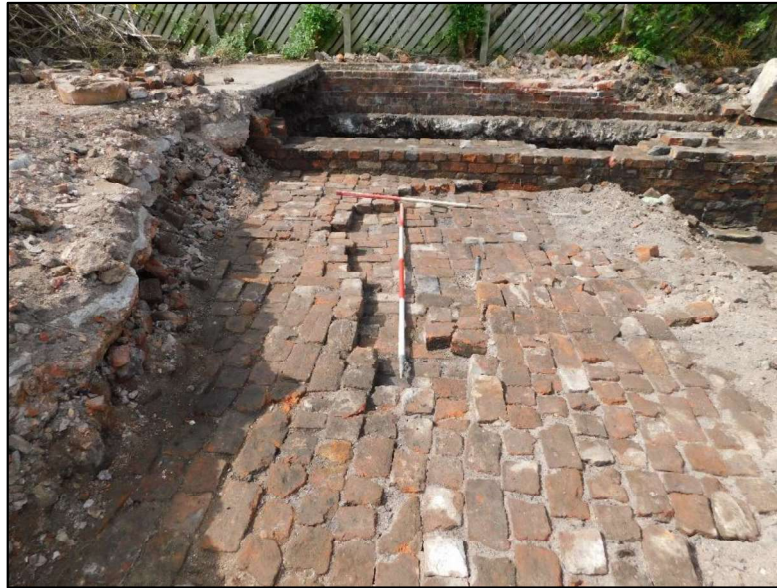
*Plate 27: Shot of brick floor surface [106] and wall [107], looking north-west. Scales = 1 x 1m and 1 x 2m.*

- 6.10.19 Brick floor surface [106] was located in the south-easternmost corner of the area, was aligned north-east to south-west, and measured a maximum of 4.08m long x 2.22m wide (Plate 27). It was composed of handmade, unfrogged red brick, with no visible bonding pattern and was abutted by wall [107] on its north-eastern face.

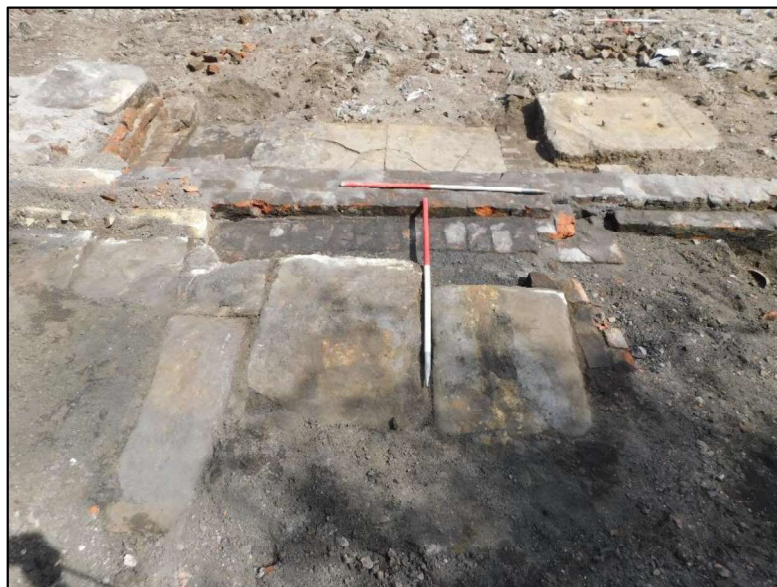
*Plate 28: Shot of walls [122] and [119], and surface [118], looking north-east. Scales = 2 x 1m.*

6.10.20 Wall [122] was located in the north-western corner of the area abutting wall [119] along its south-western face. It was aligned north-west to south-east, and measured a maximum of 1.87m long x 0.25m wide (Plate 28). It was composed of hand-made, unfrogged red, laid header bond, and bonded with a sandy lime mortar. This wall measured 25.54m aOD at its highest level. Surface [118] was located south-west of wall [122], was aligned roughly north-west to south-east and measured 1.76m long x 1.22m wide x 0.06m thick (Plate 28). It was composed of Yorkstone flags laid irregularly and measured 25.65m AOD at its highest level.

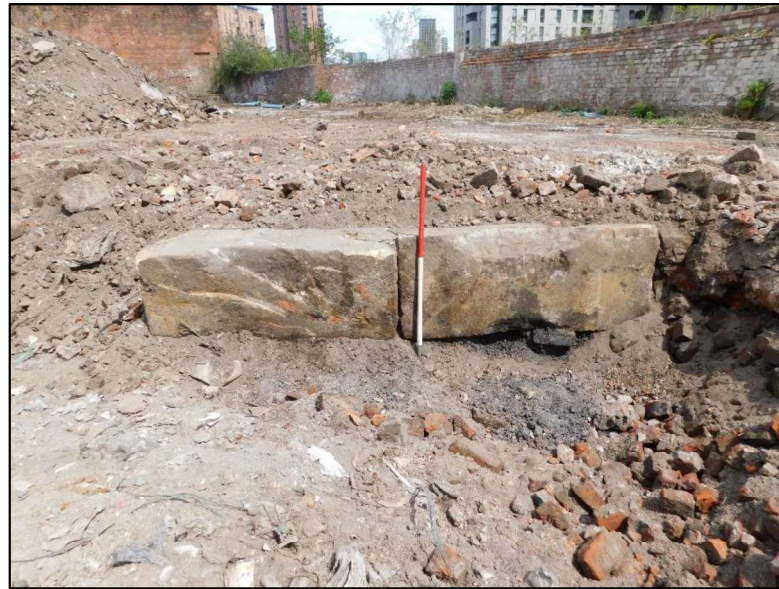
*Plate 29: Shot of sandstone blocks [120], looking north-east. Scales = 1 x 1m.*

6.10.21 Stone blocks [120] was located in the north-eastern corner of the area, were aligned roughly north-west to south-east, and measured a maximum of 2.87m long x 0.46m wide x 0.60m thick (Plate 29). [120] was composed of two sandstone blocks, which had smooth faces with carved cut outs for machinery fixings. The blocks highest level measured 25.79m aOD and at their lowest measured 25.21m aOD.

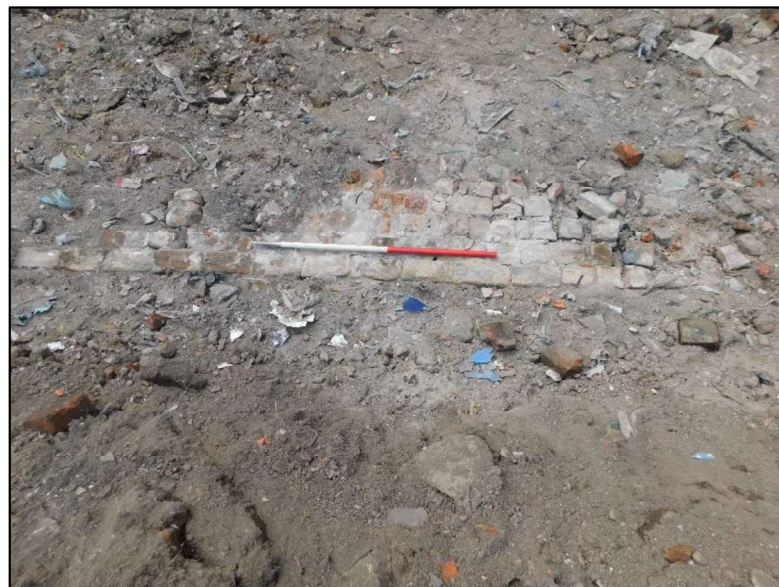
*Plate 30: Shot of surface [121], looking south-west. Scales = 1 x 1m.*

6.10.22 Surface [121] was located in the north-western corner of the area, was aligned north-west to south-east, and measured a maximum of 5.40m long x 0.62m wide (Plate 30). It was composed of handmade, unfrogged red brick, laid stretcher bond, and bonded with a sandy lime mortar. Its highest level measured 25.03m aOD.
