## Phase I Geo Environmental Desk Study

No.8 The Pingot

Irlam

Report No. A2714/18

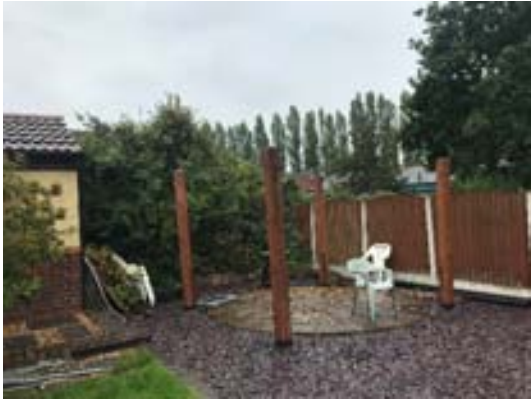
| <p><b>Plate 1 View of northern part of site, looking SE</b></p> | <p><b>Plate 2 View of northern part of site with pond in foreground, looking S onto fence which divides the site</b></p> |

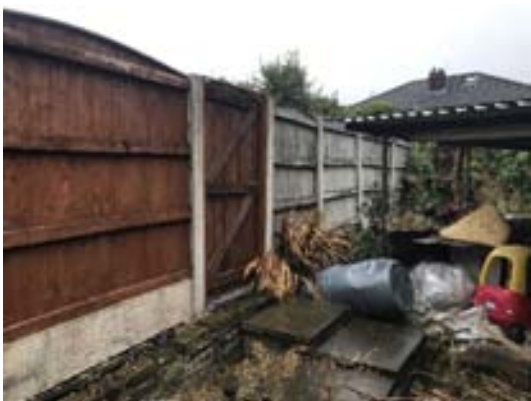
| <p><b>Plate 3 View of access gate and steps down into the southern (enclosed) part of the site, looking NE</b></p> | <p><b>Plate 4 Power supply and filtration system for pond, looking W</b></p> |

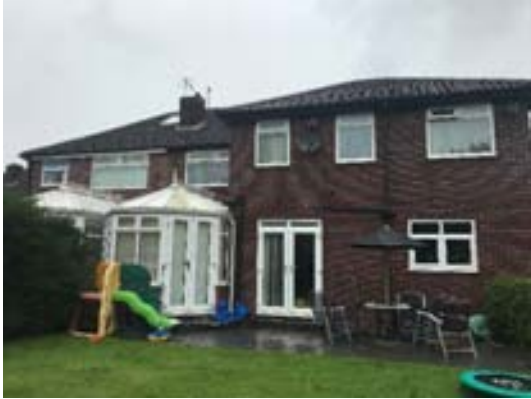
| <p><b>Plate 9 Southern elevation of No.8 The Pingot (offsite)</b></p> | <p><b>Plate 10 Northern elevation of No.8 The Pingot (offsite)</b></p> |
